Subject: Guam Department of Public Works, Proposed Ajayan Bridge Replacement  
Project Project No. GQ-ER-0004(114)/GU-NH-0004(114)  
Request for Species List

**Subject: Route 4 Ajayan Bridge Replacement**  
**FHWA Project No. GQ-ER-0004(114)**  
**Section 7 Endangered Species Act**

## Flora and Fauna Surveys for Ajayan Bridge Replacement Project

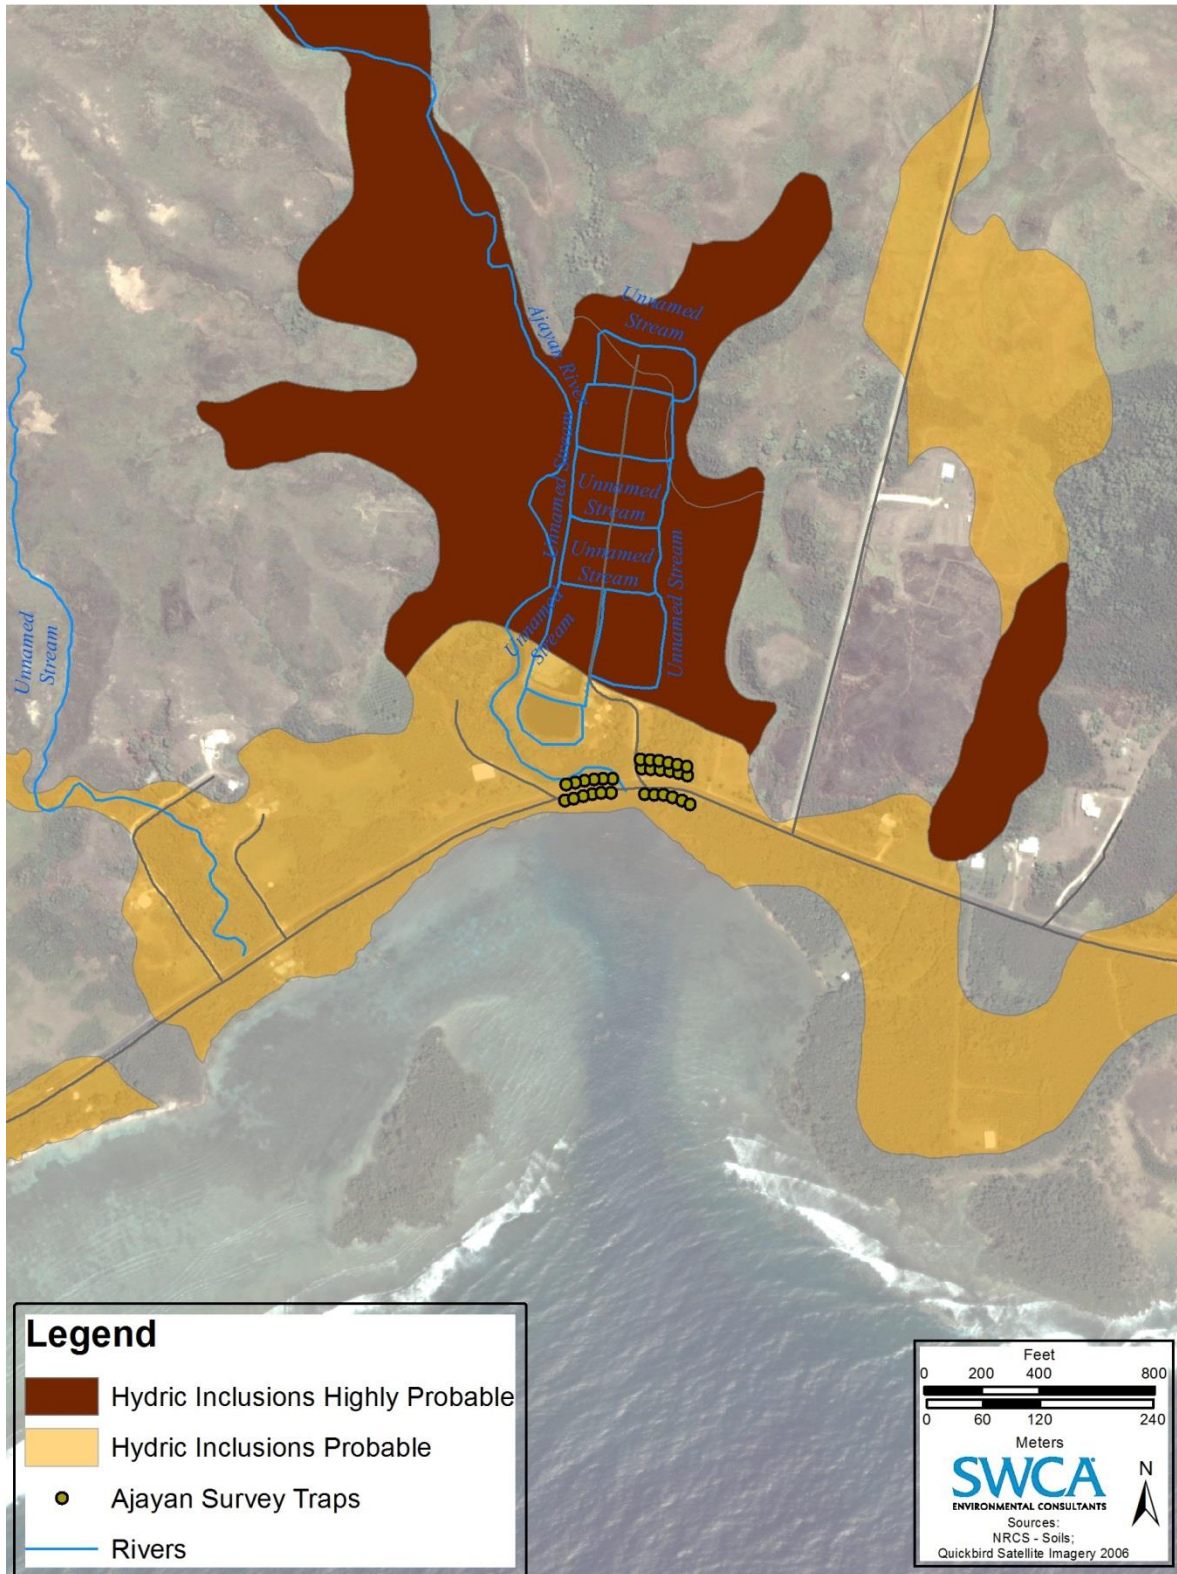
Figure 3. Hydric Inclusions Probability

In the Inarajan watershed are the soil types Ylig clay, Togcha-Akina silty clays, Sasalaguan clay, Pulantat clay, Inarajan clay, Chacha clay, badland, Ajayan clay, Shioya loamy sand, rock and urban land complex (WERI 2011a). The soil types in the Manell watershed mainly include Ylig clay, Akina silty clay, Akina-Atate silty clays, Sasalaguan clay, Pulantat clay, Lulantat-Kagman clays, Inarajan clay, Togcha-Akina silty clay, badland, Agfayan clay, Shioya loamy sand, rock and urban land complex. Soils on the proposed project site are probable for hydric inclusions (Figure 3) and fall within area characterized as Inarajan clay

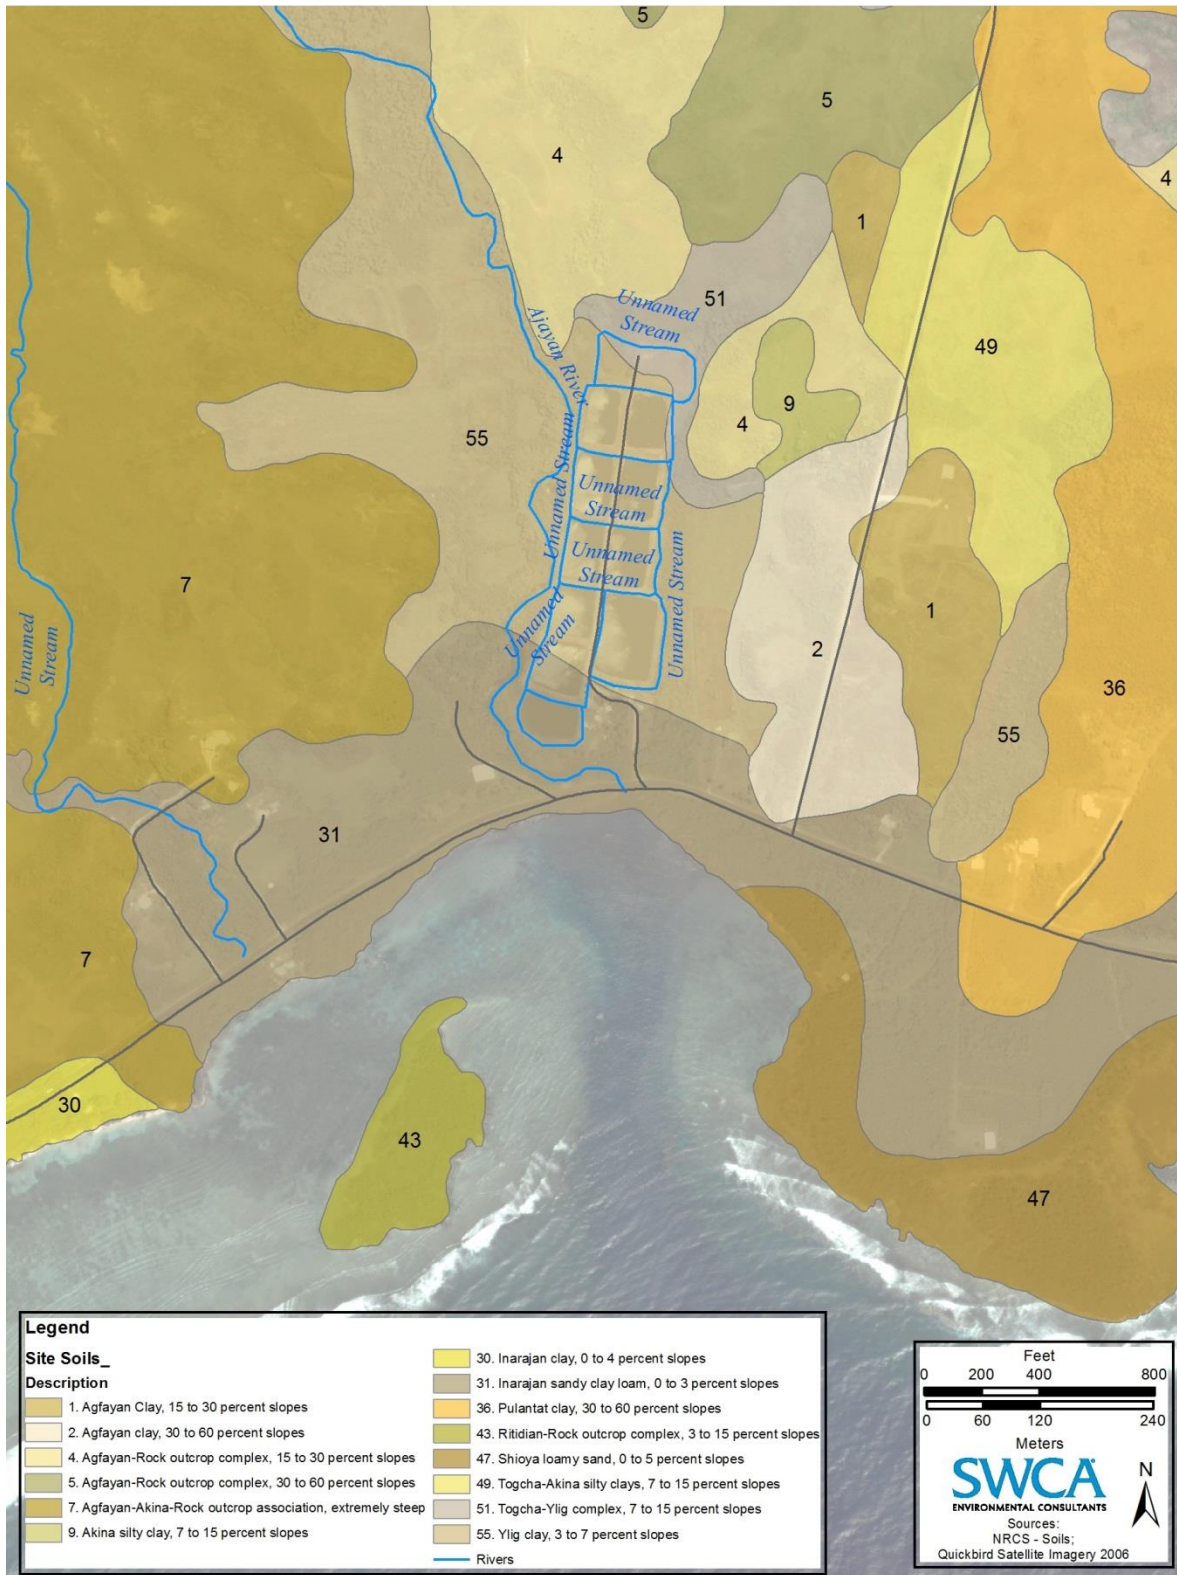
Figure 4. Site Soils Characteristics

(Figure 4). Inarajan clay is a very deep, poorly drained, slowly permeable soil that occurs along valley bottoms and coastal planes. This soil forms from alluvium derived from volcanic rock. Alluvium is composed of material, such as sand, silt, or clay deposited on land by streams. Vegetation that grows in uncultivated areas of Inarajan clay are mainly wetland plants, grasses, and sedges (Young 1988).
